Arboricultural Risk Assessment – Kennedys Bush Track

A tree risk assessment was carried out on Thursday 23rd March, between 1.30 & 3.00 pm, to view trees at areas 1 & 2 relevant to the recent fires, tree damage and potential risk associated with standing dead / damaged trees. A further site visit, as requested, was carried out on Wednesday 29th March, between 8.00 & 11.30 am, covering areas 3 – 6.

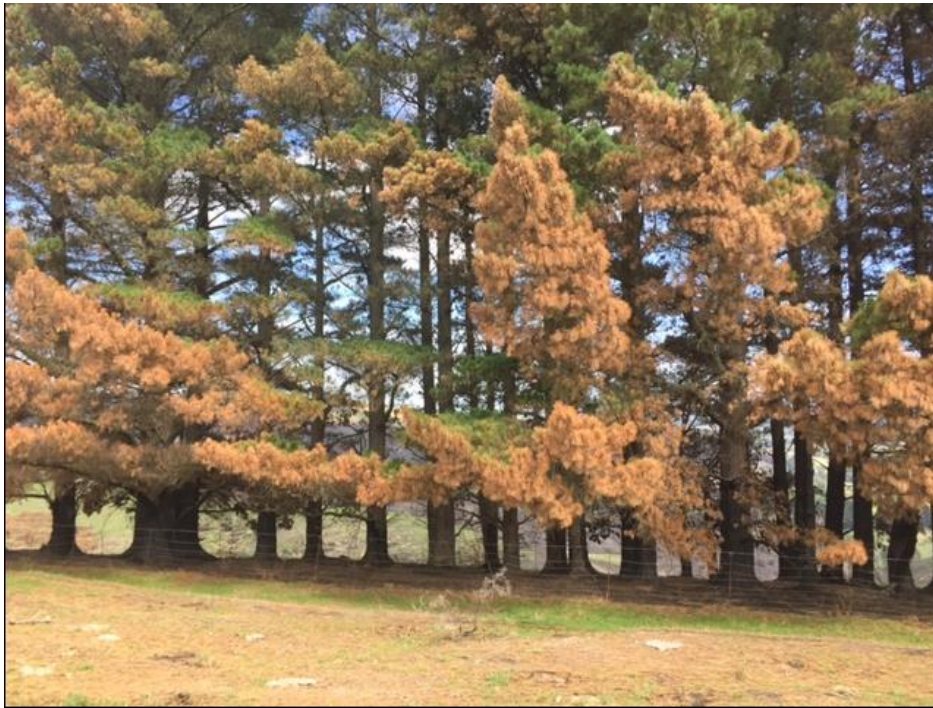
Area 1 –

Trees in this group have sustained varying degrees of damage from the recent fires.

Fuel on the ground, in addition to the intensity and duration of burn time, has left the base and exposed buttress root system severely damaged.

A sounding hammer was used around the entire circumference of 1 tree – tone was consistent indicating that wood density was consistent, with no apparent decay pockets at the height of sounding.

We chipped bark from the base of a tree to gauge damage – although the cambium was still moist to the touch (fire damage limited to outer bark) the intensity of the fire has severely scorched the foliage and buds, which will highly likely lead on to tree mortality, in the following months.

Degradation of trees' structural integrity will continue:

- Branches will dehydrate, become brittle and start to fail
- Standing dead trees will be targeted by bark beetles and other insects which will invade the trees, possibly as vectors for fungal infection. This will further degrade the trees' structural integrity.

The bike track is within the canopy spread of some of the trees.

Total tree failure is highly unlikely at this point, but with increased wind it is possible that lateral branches may fail due to the increased rate of dehydration and subsequent loss of flexibility.

- Frequency of occupation – low
- Likelihood of failure – probable
- Consequences – severe

It is recommended that risk mitigation be initiated as soon as possible, 2 options are presented for consideration:

- Move track (targets) away from the tree line, preferably 1.5 tree lengths, to keep targets outside the potential fall and shatter zone
- Remove hazards, in this instance the standing dead / dying trees.

Risk mitigation should include one of the above options, the most practicable considering time constraints.

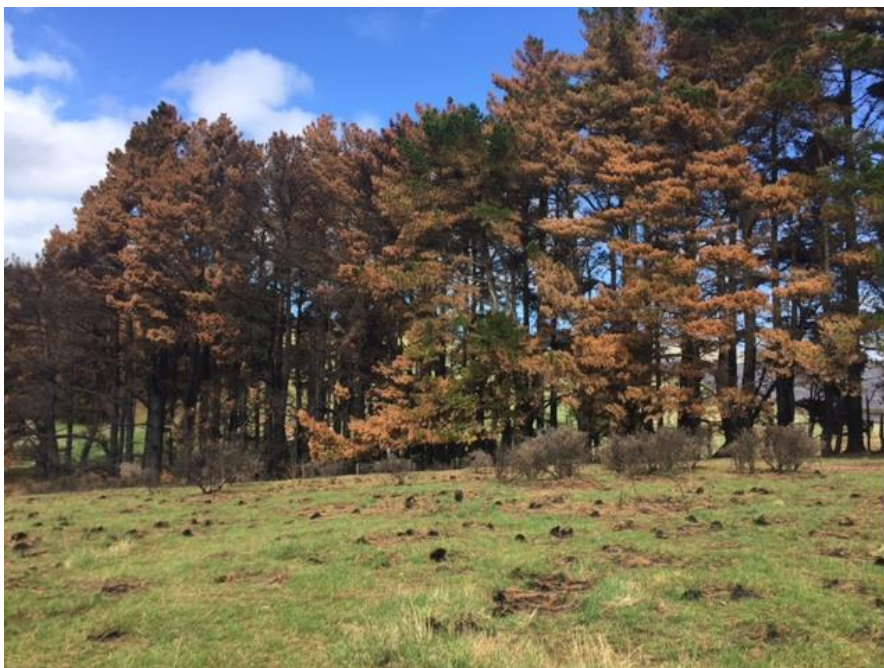
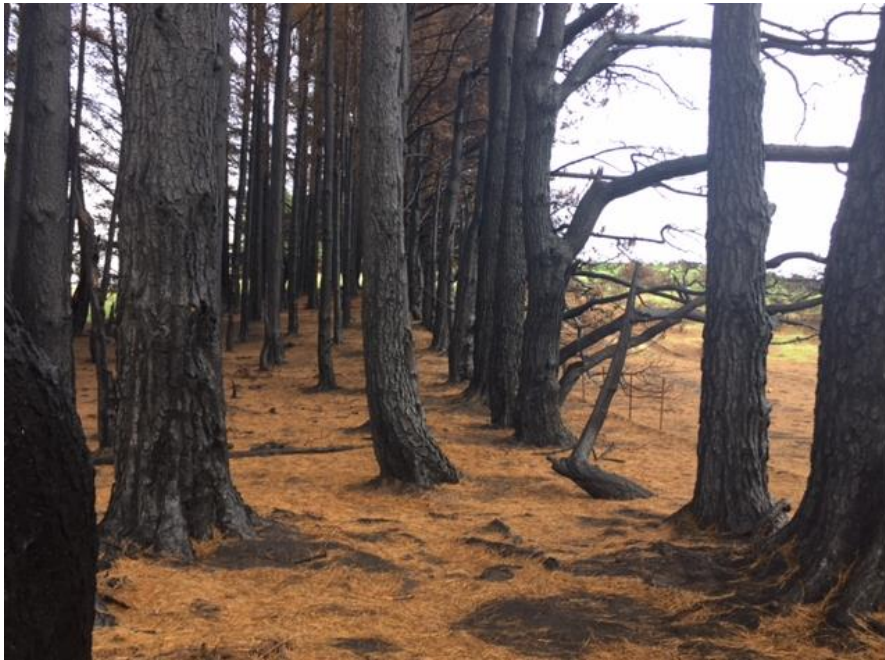
Area 2 –

Standing dead trees, some are burnt entirely with no chance of recovery

Trees in this group have sustained varying degrees of damage from the recent fires.

Fuel on the ground, in addition to the intensity and duration of burn time, has left the base and exposed buttress root system severely damaged.

We chipped bark from the base of a tree to gauge damage – although the cambium was still moist to the touch (fire damage limited to outer bark) the intensity of the fire has severely scorched the foliage and buds, which will highly likely lead on to tree mortality, in the following months.

The track is just outside the canopy spread of the trees at the south – eastern corner of the block, but is within the potential fall radius.

Risk in this location is increased due to the occupancy rate – track users will be in the potential fall zone for a longer duration as they stop to open and close the gate.

Total tree failure is highly unlikely at this point, but with increased wind it is possible that lateral branches may fail due to the increased rate of dehydration and subsequent loss of flexibility.

- Frequency of occupation – low - medium
- Likelihood of failure – probable
- Consequences – severe

It is recommended that risk mitigation be initiated as soon as possible:

- Removal of trees at the south – eastern corner of the block, so that there is 1.5 tree lengths clearance from the gate.

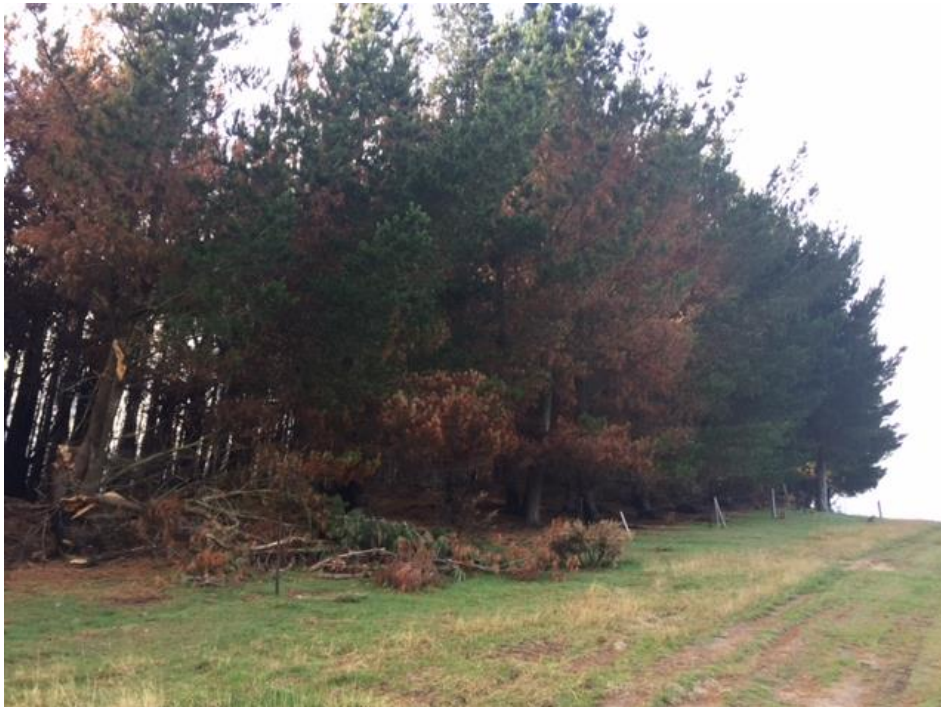
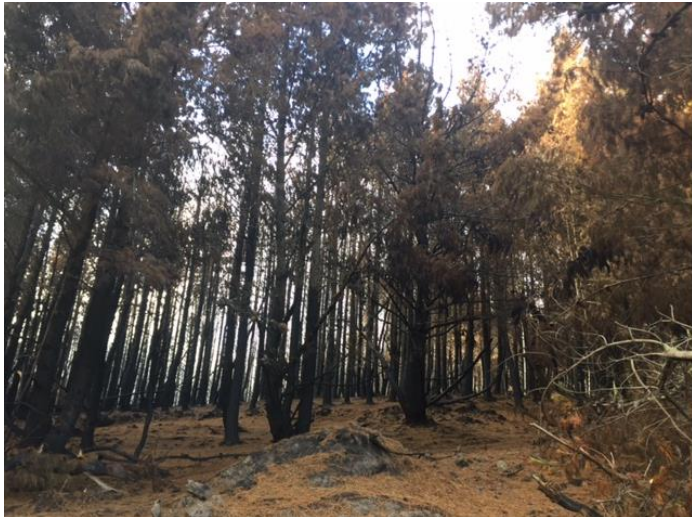
Area 3 –

Standing burnt trees, internal

Internal trees have been severely affected by the fire, many of the edge trees beside the track are still green – failure potential of burnt trees is still high but foliage from edge trees will slow down the descent of inner trees that fail.

Walking & bike track approximately 9 meters from edge of trees, tree height approximately 12 meters.

Move the track to at least 12 meters from the trees will move the targets outside the fall radius, lowering the risk rating to low.

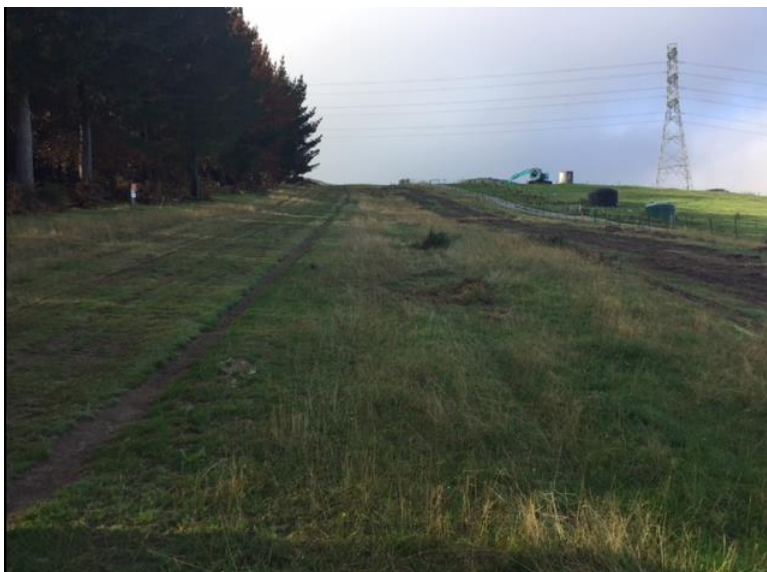
Area 4 –

The track is currently located within the fall radius of the inner burnt trees.

The corridor between fences is approximately 21 meters wide – the track could be moved out to approximately 15 meters from the base of the tress, effectively moving the targets out of the potential fall radius.

Residual risk rating is very low.

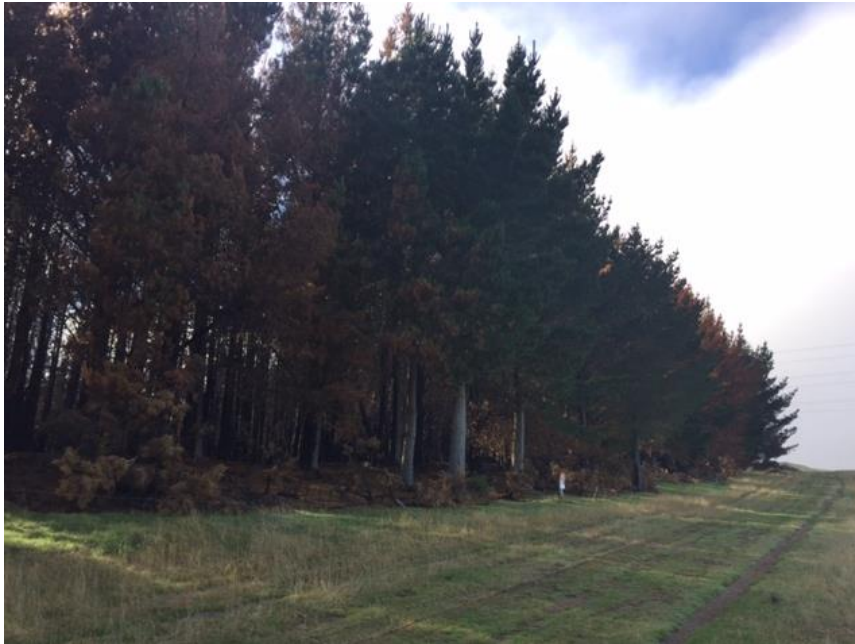
Area 5 –

The burnt inner trees start at approximately 20 meters into the group from the edge trees, which will provide some shelter from potential tree failures.

Risk rating is low.

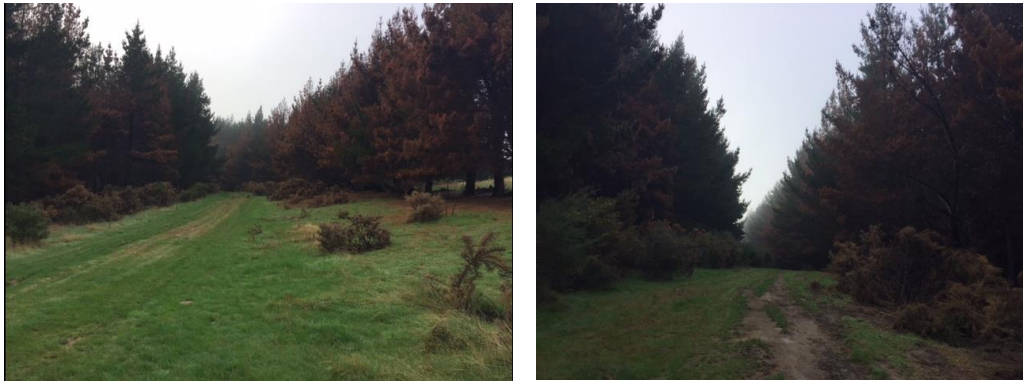
Area 6 –

The track at this point enters a corridor with burnt trees on both sides.

High potential failure risk with targets within the fall radius.

The only option to mitigate risk in this area is to fell the line of trees to the right in the above photo, and detour track users to the alternative route, shown as 7 on the attached plan for the sites, page 8. There is a clear corridor that will provide clear space for track users, well clear of the trees.
